## **District 5**

# PRIMARY RECORD

Resource Identifier: Alma Forest Fire Station

- P10. Report Citations:** (Provide full citation or enter "none") A Survey and Historic Significance Evaluation of the CDF  
Building Inventory, 1994 Mark V. Thornton

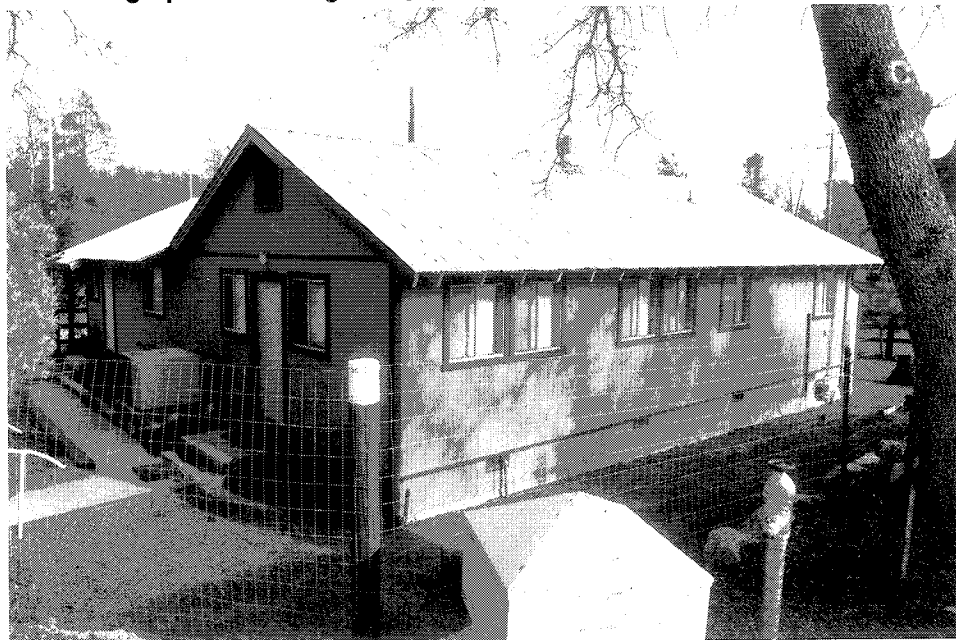
Northern and western elevations of the combination barracks.

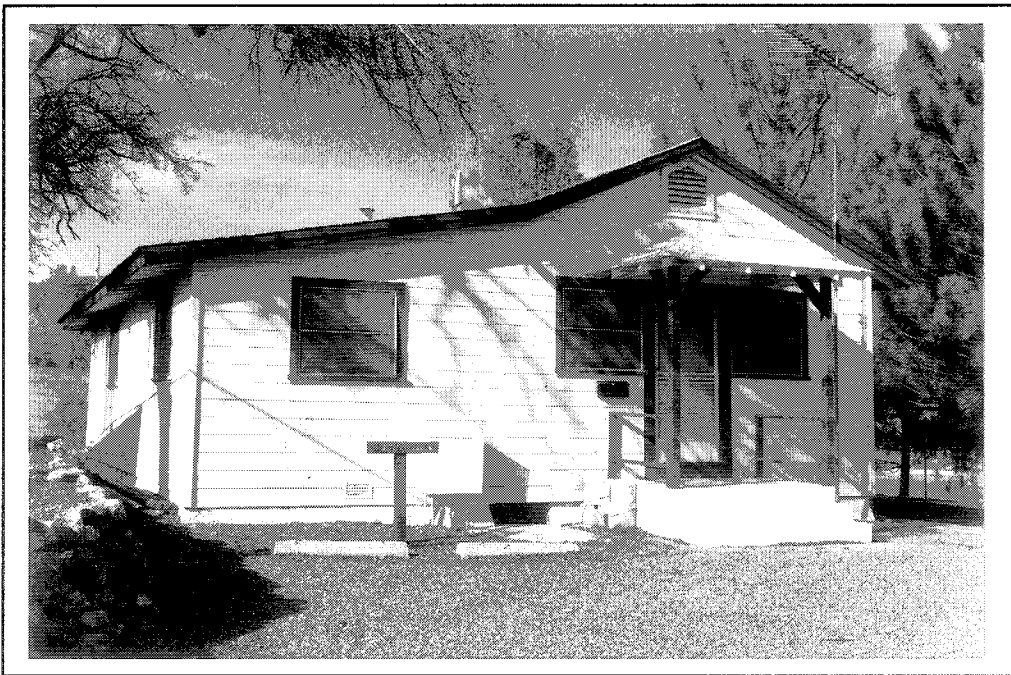
Single panel "chevron" louvered attic vents are centered in each gable. This building is no longer occupied by CDF (the compound site is leased). The kitchen-messhall is leased by a private telephone company. A 1975 apparatus building is to the northwest of the combination barracks. The station is surrounded by oak woodland, open range, and brush lands. The station was originally known as the San Antone Forest Fire Station. A few years ago it was renamed Sweetwater Forest Fire Station after an area resident complained about the continued practice of corrupting San Antonio to San Antone. The station is located in San Antonio Valley but the San Antone appellation has been used in the area for other properties, for many years. There is a San Antonio Forest Fire Station in the CDF system, so the name was changed to Sweetwater (after a nearby creek) to placate the local and avoid confusion with the southern California fire station.

Western and southern elevations of the former kitchen-messhall.
